**CASE REPORT****RETRIEVAL OF A MIGRATED CENTRAL VENOUS GUIDE WIRE: A CASE REPORT**M.G.M.A Bandara<sup>1</sup>, P.A.H.M.M.B.B Herath<sup>1</sup>, J.Udupihilla<sup>2</sup>, P.B Hewavithana<sup>2</sup><sup>1</sup>Teaching Hospital, Peradeniya.<sup>2</sup>Department of Radiology, Faculty of Medicine, University of Peradeniya.

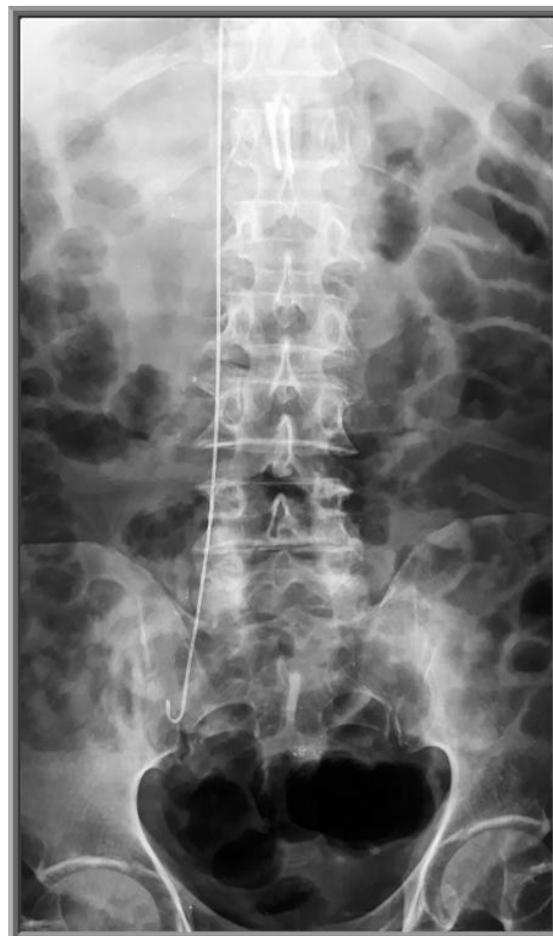
**Figure 1:** “J” guide wire extending from sub hepatic IVC in to right common iliac vein (course through right atrium and supra hepatic IVC not shown)

This had led to the use of multiple guide wires to obtain access to the collapsed central veins. The missing guide wire was noted at the end of the procedure. As the guide wire could not be visualized on sonography, chest X-ray was obtained and it revealed that the guide wire was projected over the cardiac shadow in a straight course with the distal end at the level of the L5 vertebra, angled towards right, raising the possibility of migration into the right common iliac vein. Since wire retrieval was not feasible, the patient was transferred to a tertiary care hospital. Subsequent CT thorax and abdomen showed the exact location of the guide wire, extending from the SVC to the right common iliac vein, through the right atrium and inferior vena cava (IVC) (Figure 1). The patient was optimized for the interventional procedure and the retrieval was done using a Gooseneck snare (Figure 2) under fluoroscope guidance.

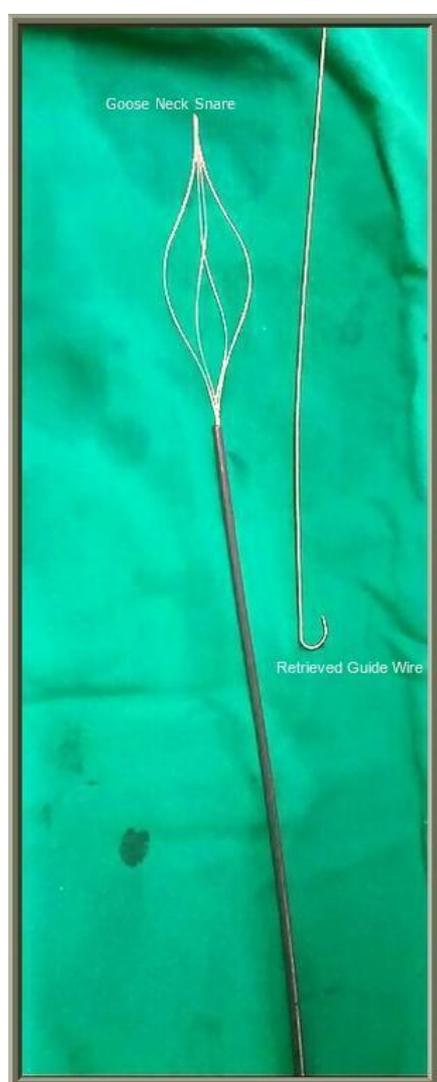
**Figure 2:** Retrieved “J”guide wire (right).Goose neck snare(left) used to retrieve “J” guide wire

case, the guide wire was retrieved through right femoral vein access by using a Gooseneck snare under fluoroscopy guidance. It is not easy to retrieve a guide wire when it is kept within the blood vessel for few days, as a thrombus can be formed around the wire. In this case guide wire was taken out after one week, when the patient was stable enough to undergo an intervention. At the time of retrieval, guide wire had adhered to the vessel wall and catching it in to the gooseneck snare was not found to be easy. However, successful retrieval of the intact wire was achieved without any complications.
